TITLE: Unit 2 burner injector / burner replacement

DESCRIPTION: Repair or replace all 48 ABT burner nozzles during the 2008, Unit 2 outage.

Intermountain Generating Station
Unit 2 Burner Injector and Burner Elbow Replacement

**Intermountain Power Service Corp.
ABT Siemens Warranty Claim**

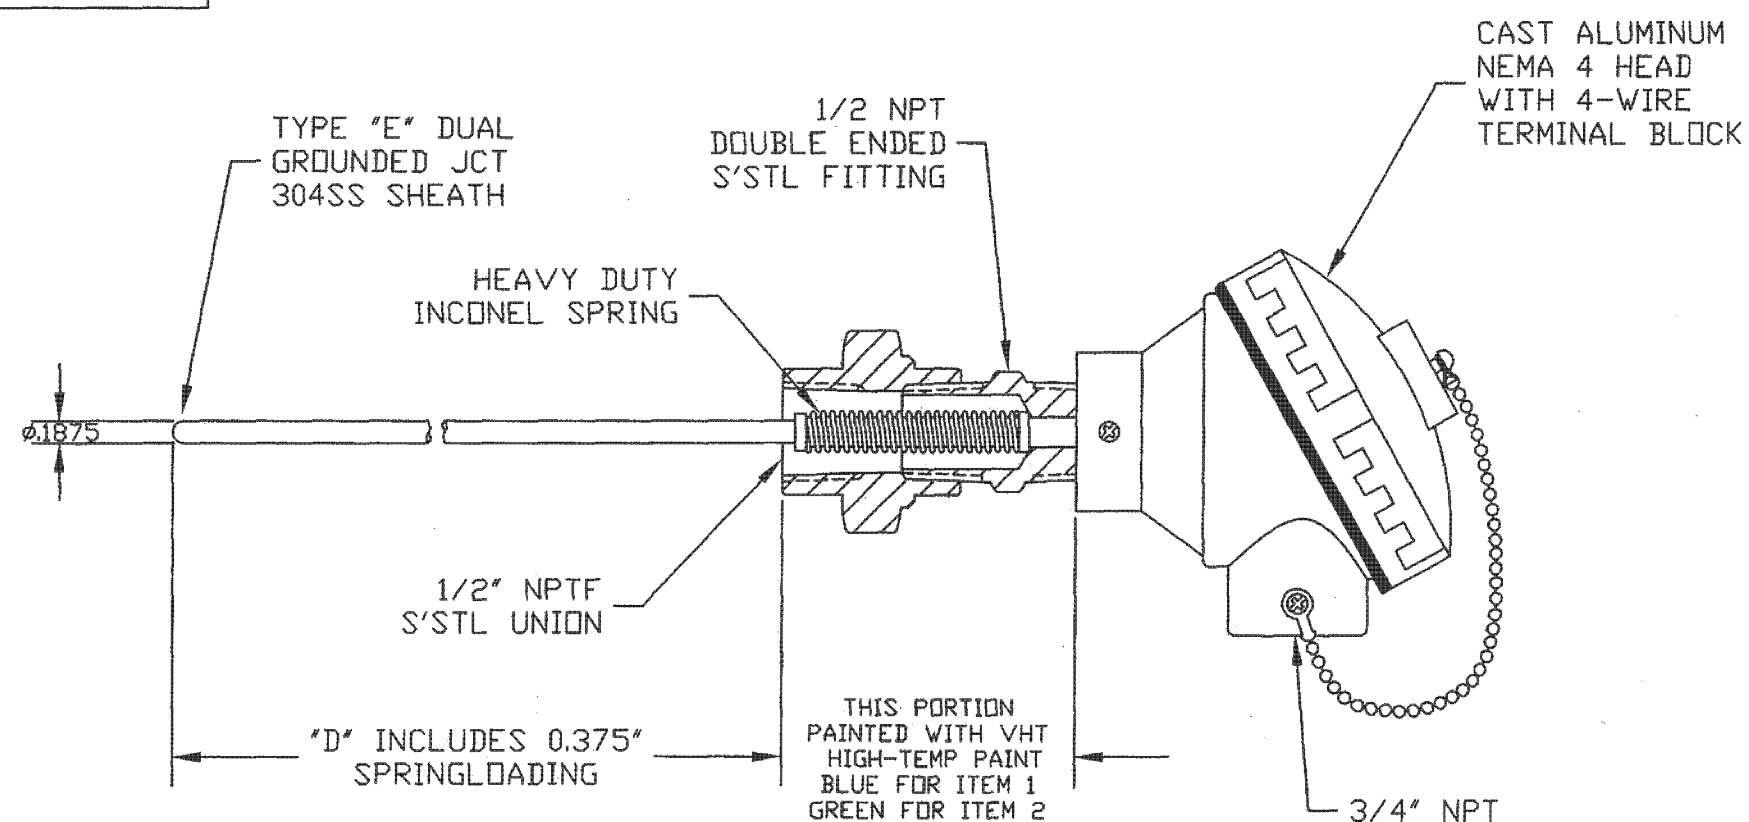
REV
 ST-8866B-[]

NO SPECIAL INSTRUCTIONS FOR INSTALLATION.
 PUSH T/C INTO TUBE AND TIGHTEN UNION.
 3/16 MIC WILL BEND EASILY TO FIT NOZZLE.

Item No.	Qty Required	"D" Dim	Item Description	Part Number
1	48	105.69	Fuel Injector Nozzle	ST-8866B-1
2	48	69.97	Fuel Body Temp	ST-8866B-2

Can you check with the customer with regard to the thermocouples? In the past we provided a waterproof head that they wire into (sketch attached). Please confirm that this arrangement is best for them.

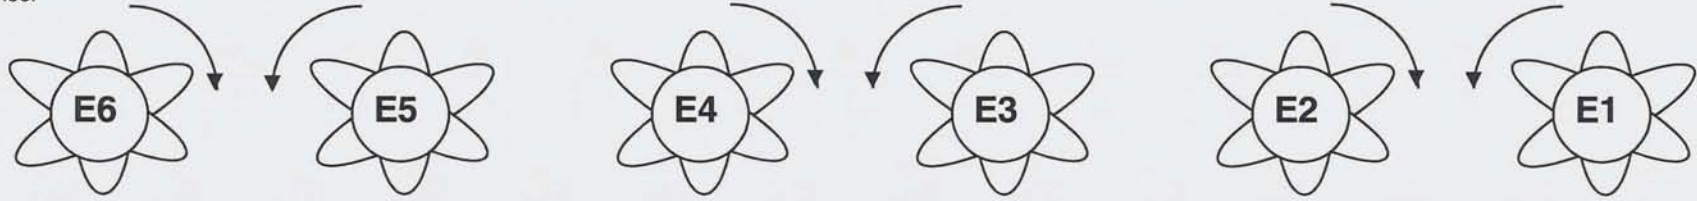
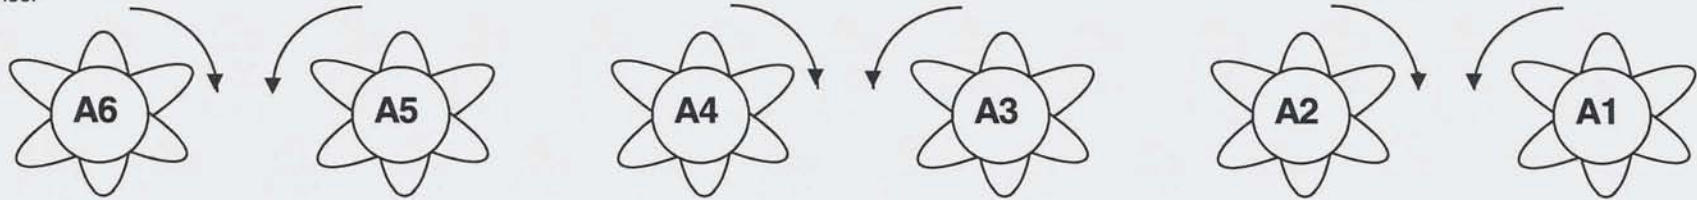
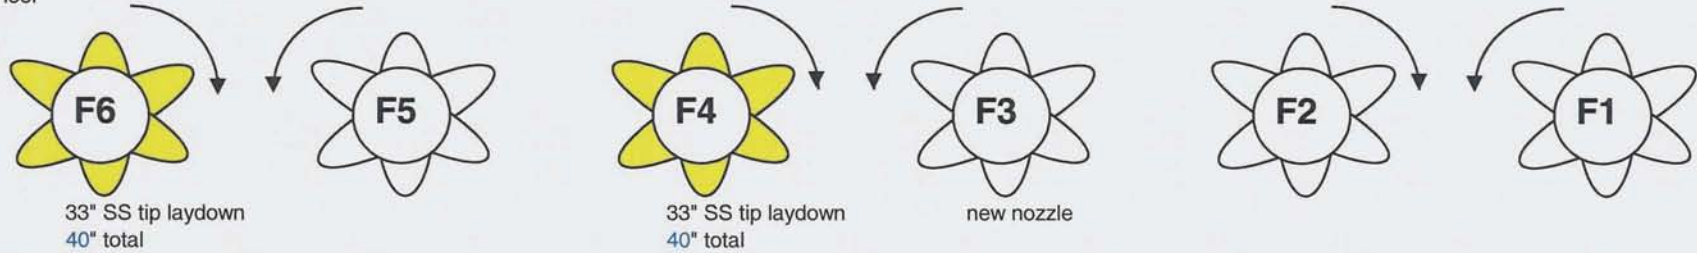
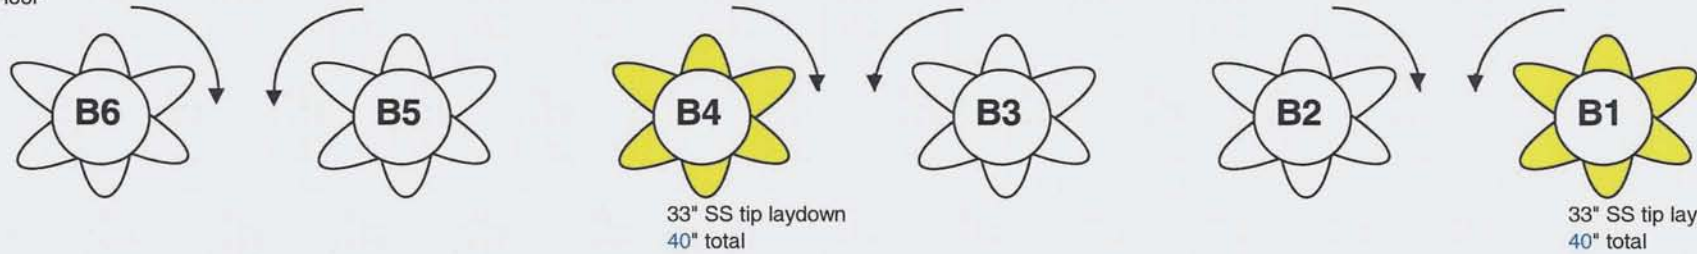
Tips removed and replaced designated in yellow, all others were repaired with segment wear liners on all 6 pedals.

Front wall looking North (Tips to have air sleeve moved back.) **Tip to be replaced**

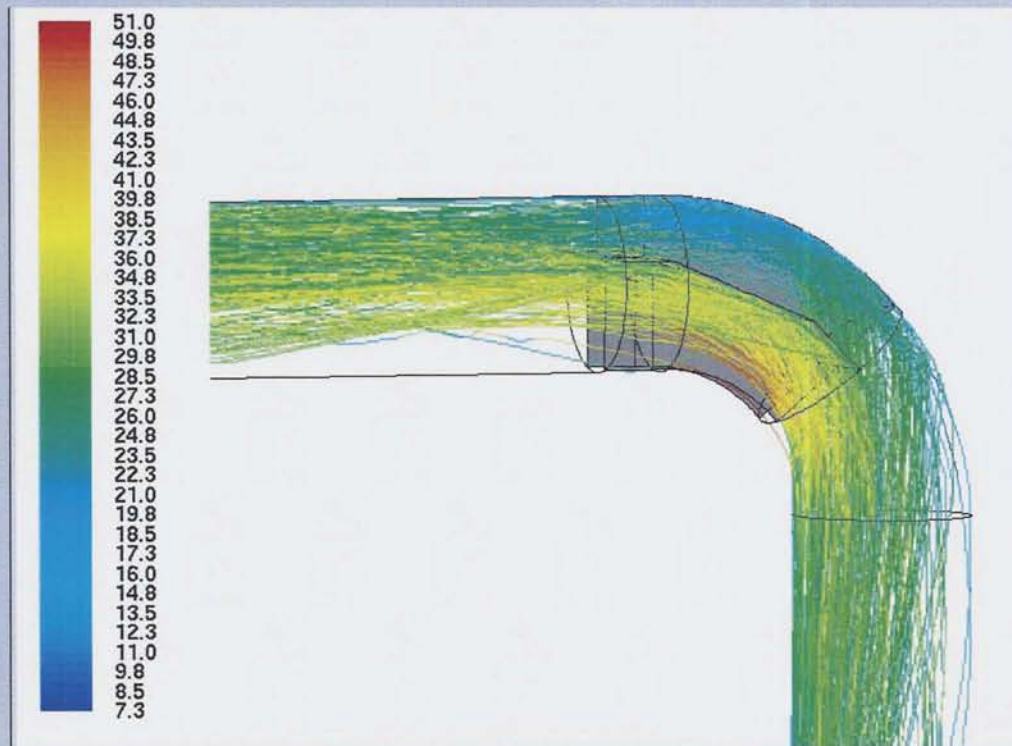
Erosion and Mill Air Flow

The CFD model shows the coal particles are stratified entering the elbow. The original kicker assembly with the X-vane that was modified to retain the clean out port will not last in the high velocity stream of concentrated coal particles with the higher coal flow.

The revised fuel injector design will increase the cross sectional area of the nozzle to reduce velocities, lengthen and flatten the slope of the transition ramp and replace the round elbow with a "Flat back" design to allow dispersion of the coal particles across the flow area of the nozzle.

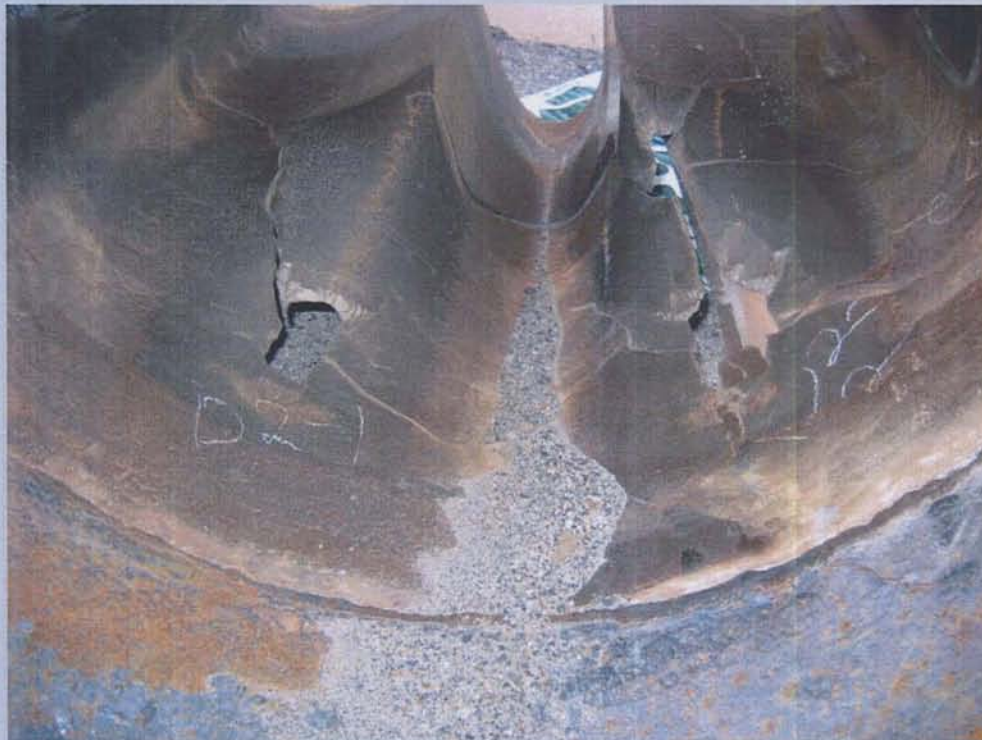
Erosion and Mill Air Flow

Erosion is originating at the transition slope from the round barrel to the 6 lobe exit. This is consistent with the results of the CFD model. The metallurgical analysis performed by Tordonato Energy Consultants identified erosion as a the contributor cause of the nozzle cracking. The high temperatures at the weld between the nozzle and burner barrel increased the stress which also contributed to the cracking. There was no evidence of corrosion.

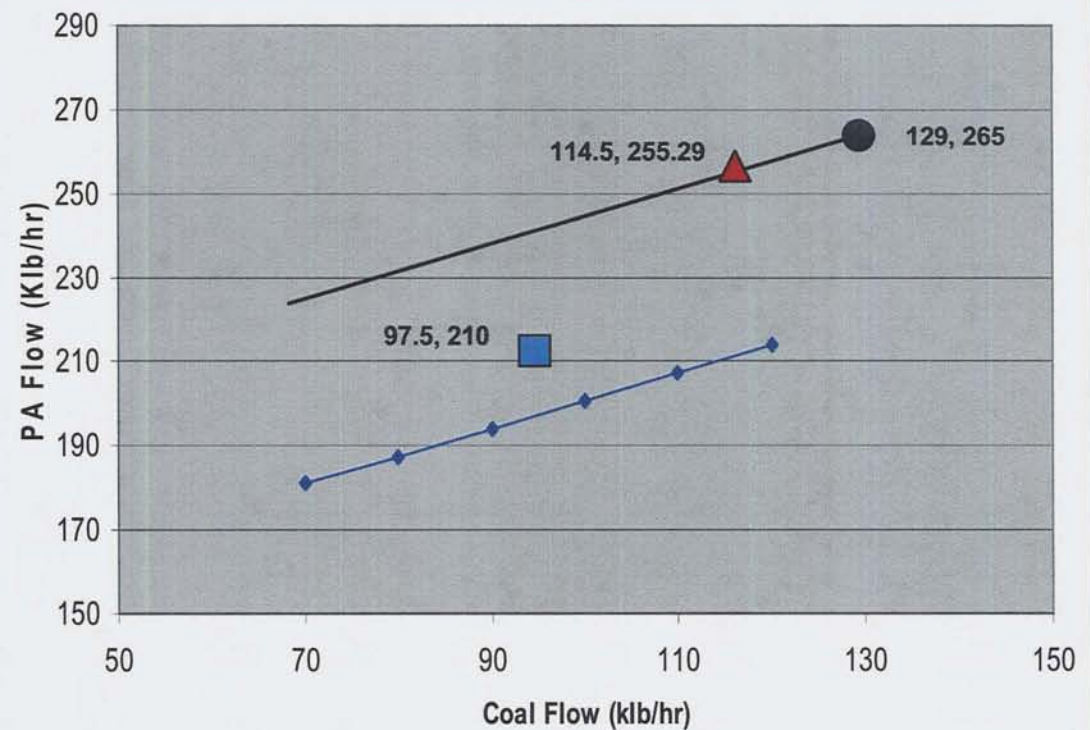
IPSC - Unit 2
MPS-89 G Mill Curve

Establish the correct primary airflow for normal operation – The plant has not been operating per the B&W mill performance curve supplied in the contract. The mill curve supplied in the contract did not reflect the revision by B&W in 1992. Also, the plant has been operating at higher seal air flows
Definition of requirements for cooling air when the burner is out of service – the Operations and Maintenance manual will have to be revised to address out of service operation

- ◆ B&W Operating Curve
- Original ABT Design Point
- Maximum Mill Load Test Point
- Actual Operating Mill Curve
- ▲ Resized Design Point

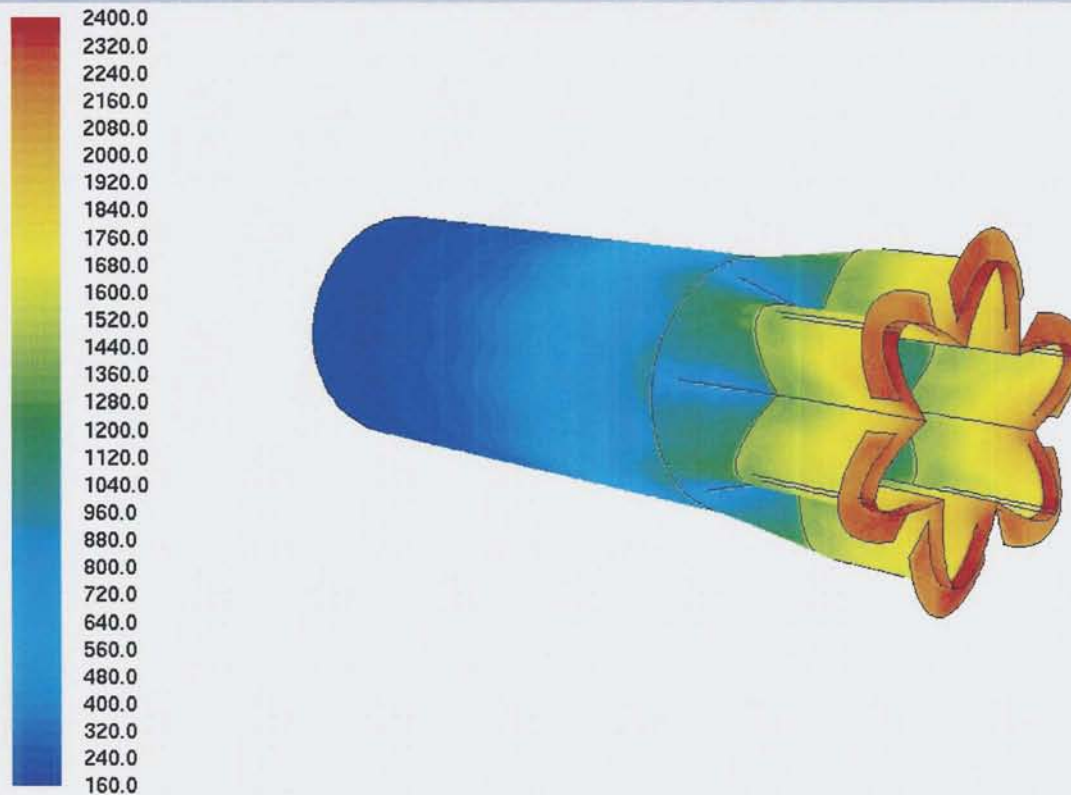
Thermal Stress

Contours of Static Temperature (f)

The furnace radiation model shows that the heat conducted back to the burner barrel to be higher than expected. The revised fuel injector will use a spool piece of 253MA stainless steel to make the transition from the nozzle to the barrel. The revised fuel injector shall use refractory tile to shield the burner barrel from radiation from the furnace and to minimize erosion. This thermal model does not model the cooling of the secondary air on the tip.

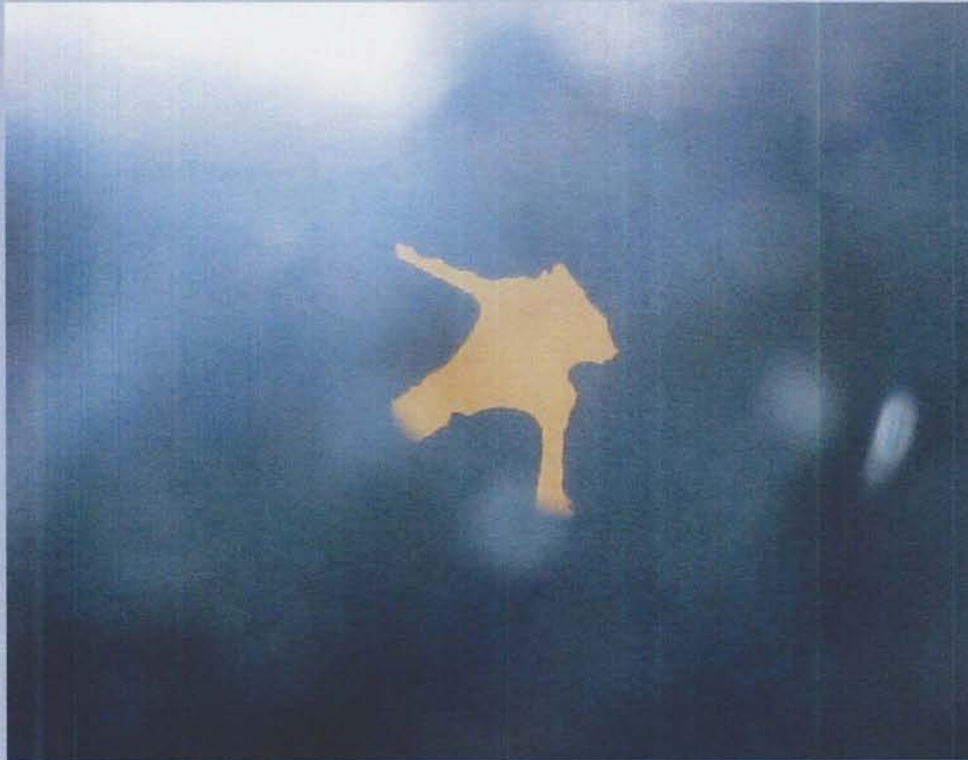
Thermal Stress

The off line burners are plugging with slag indicating that furnace gases are back flowing into the nozzle area. This creates very high temperatures that the nozzles were not designed for. A minimum air flow required to prevent this must maintained.
